SIB 52 01 21

2021-02-05

SEAT FAILS TO INITIALIZE DUE TO MISSING END STOP

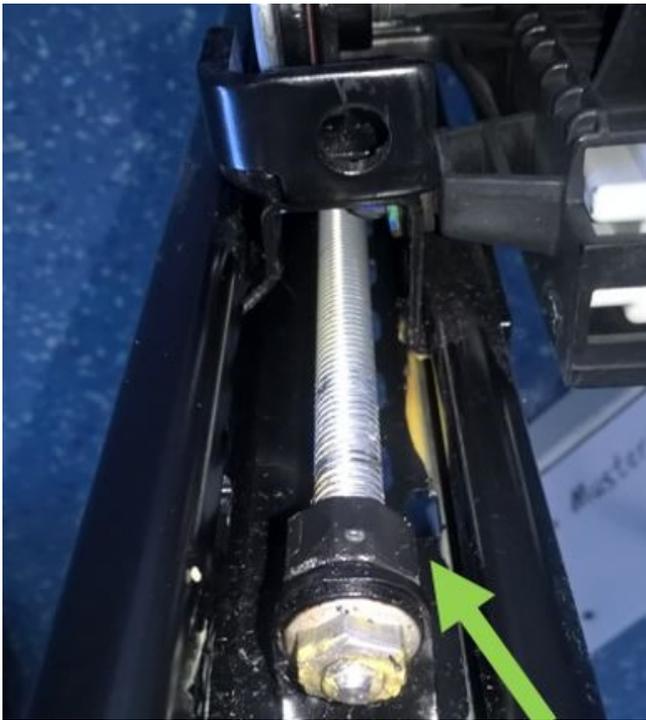
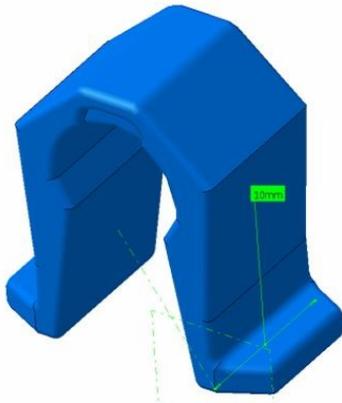
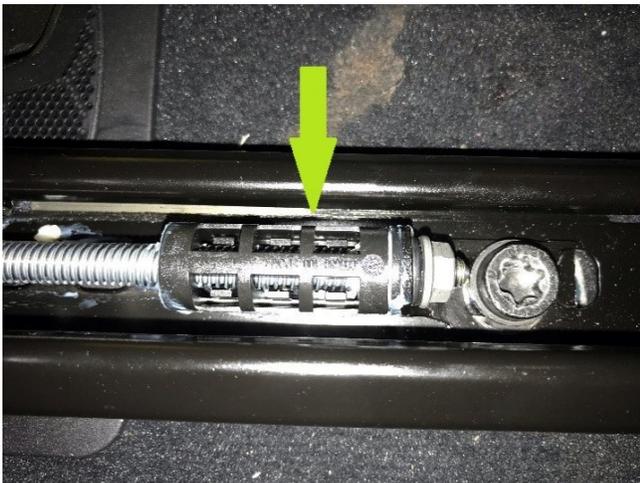
F90 G12 G30 spacer (arrow).

1. If this occurs after seat rail replacement, and the new rail does not include the end stop, then swap the end stop from the original rail.
2. If this occurs after a customer has removed the end stop:
  - Request the customer supply the end stops for reinstallation if still available
  - Order end stop if available separately in ETK, see Parts section below.
  - If the end stop is not available separately in ETK then
    - it may only come with an entire seat rail assembly.
    - contact Parts Technical Support via a TTS TSARA case for support

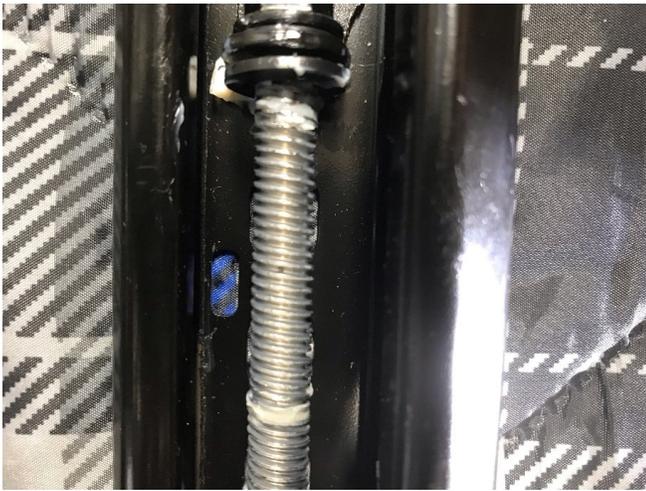
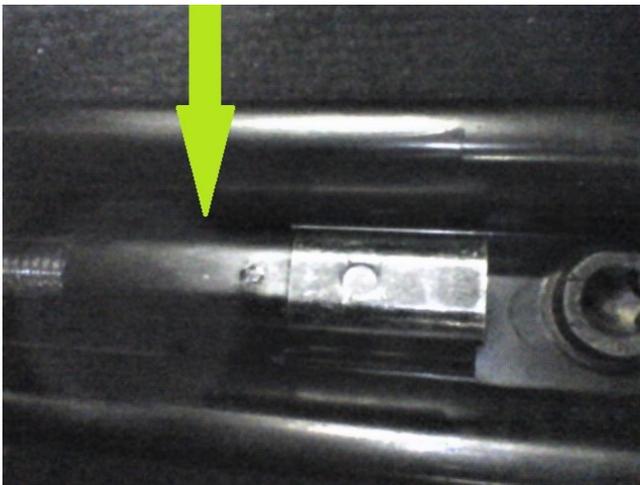
F95 F96 G05 G06 G07 spacer.

Top photo shows end stop (spacer) installed, lower photo shows rail minus the spacer.

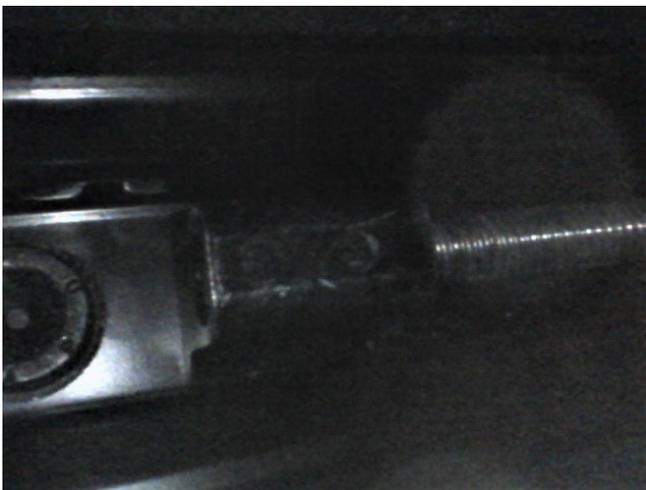
F44 spacer.

Top photo shows end stop (spacer) installed, lower photo shows rail minus the spacer.
